# Lafayette Public Library Facility Condition Assessment

Lafayette Public Library

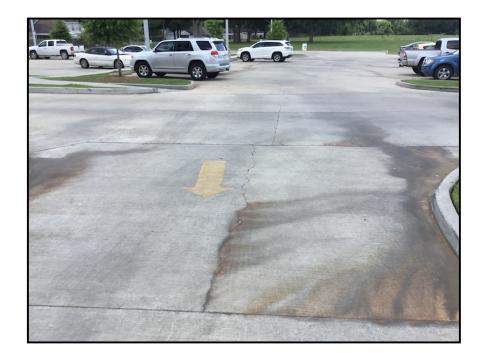
## Site Infrastructure

The concrete pavements were in overall good condition; however, replacement of the sealant in the expansion joints as part of routine maintenance would extend their overall life.

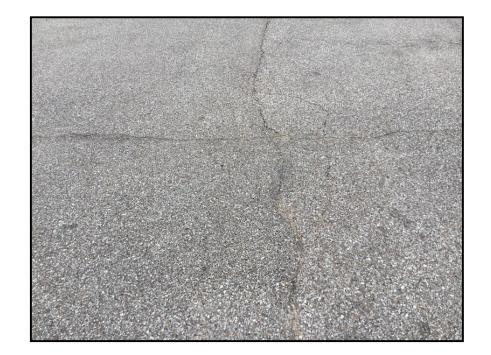
## Site Infrastructure

The asphalt pavements were generally in good condition except for a few isolated areas. Crack filling, seal coating, and re-striping would extend the overall life of the pavement.

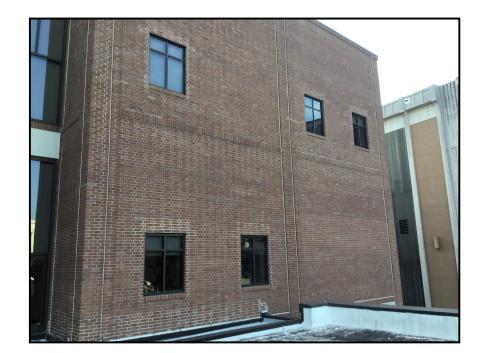
## **Exterior Enclosure**

The exterior wall finishes were a combination of brick and painted stucco. The brick finishes were original to the building and have surpassed their useful life according to BOMA. Some minor patchwork was observed; however, the system was still in good condition. Exterior windows were updated in the 2015 renovation and comprised of double-paned, insulated glass windows in good condition with no issues observed or reported.

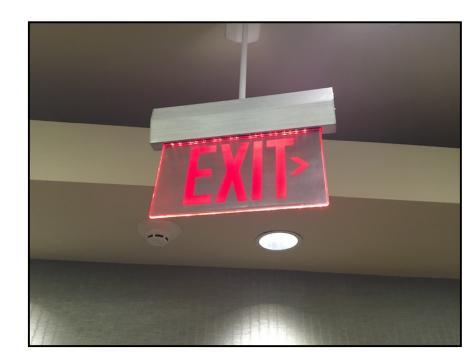
## **Fire Protection**

Exit lights and emergency lighting were present and observed to be in good condition. Battery backup has a limited life cycle and should be checked on a regular basis. Fire protection specialties were present. System components include pull stations, wet sprinklers and hard-wired smoke detectors. These systems are provided throughout the building and appear to be in good condition.

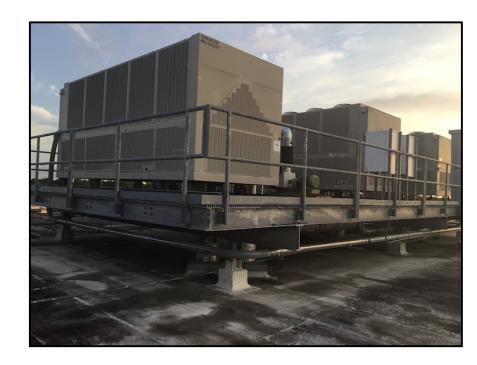
## HVAC

The Heating, Ventilation, and Cooling (HVAC) units are predominately a centralized cooling/heating system, which are replacements and are in good condition. The distribution system consists of ductwork and piping in good condition.

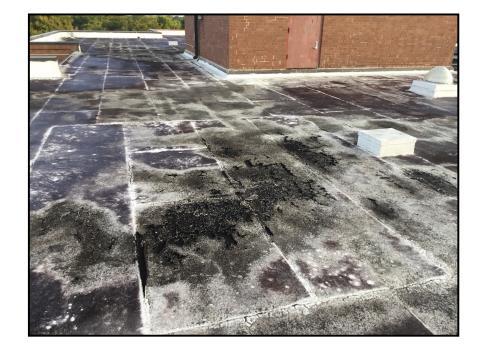
### Roofing

The modified bitumen roof covering was original. It was patched between the 2012-2013 time-frame; however, multiple roof blisters were observed at the time of the assessment. The roof was in poor condition and should be considered for replacement soon.

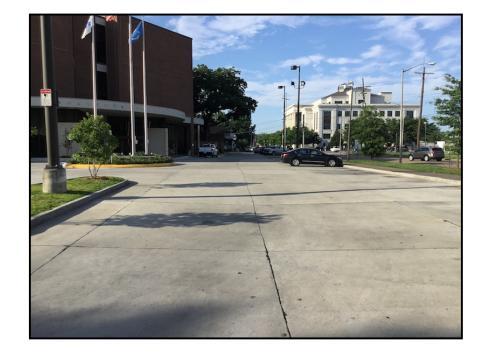
# Site Infrastructure

The concrete pavements were in overall good condition; however, replacement of the sealant in the expansion joints as part of routine maintenance would extend their overall life.

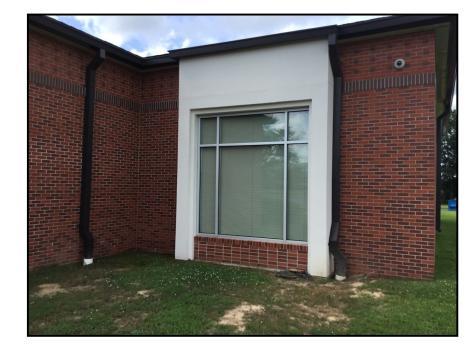
## **Exterior Enclosure**

The exterior wall finishes were a combination of brick and painted stucco. The finishes were original to the building and in good condition. Exterior windows were comprised of double-paned, insulated glass which were original to the building. Windows were in good condition with no issues observed or reported.

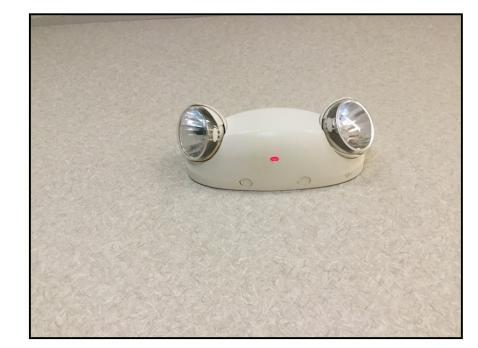
## **Fire Protection**

Exit lights and emergency lighting were present and observed to be in good condition. Battery backup has a limited life cycle and should be checked on a regular basis. Fire protection specialties were present. System components include pull stations, wet sprinklers and hard-wired smoke detectors. These systems are provided throughout the building and appear to be in good condition.

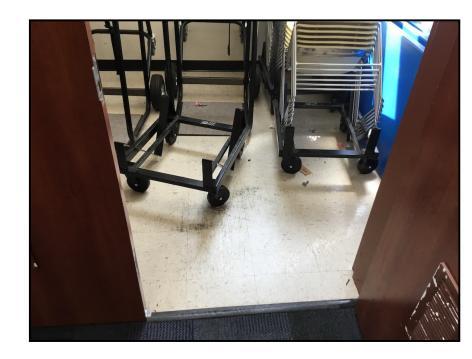
### Interiors

Floor finishes were a combination of carpet tiles, ceramic tile, and resilient flooring. The carpet tiles in the children's area have been replaced; however, the remainder of the floor coverings were original to the facility and in poor condition. The resilient flooring was soiled and deteriorated, and carpet tile seams were separating. System needs replacement soon. Ceiling finishes were comprised of acoustical tile and painted hard surfaces which were observed to be in good condition. Interior wall finishes were a combination of painted hard surfaces, ceramic tile, and wallpaper that were original to the building and in good condition.

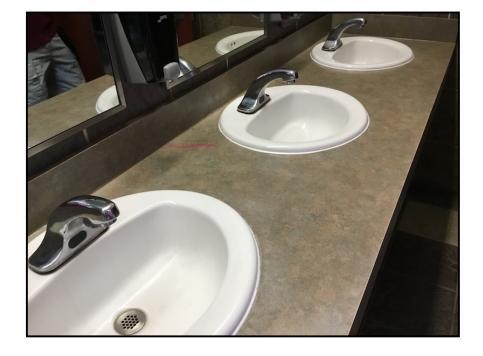
### Plumbing

Plumbing fixtures are original and are in good condition. Domestic water distribution is provided by an unknown pipe type due to system being concealed with hot water provided by a central water heater and is within its expected useful life. Sewer piping is comprised of an unknown pipe type due to system being concealed and is within its expected useful life.

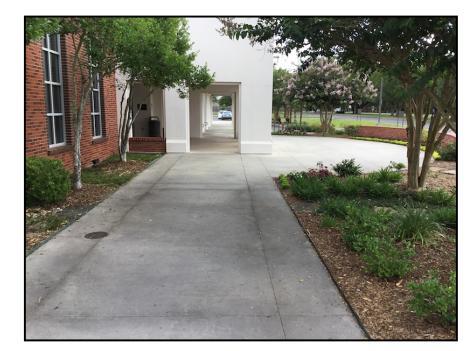
## Site Infrastructure

The concrete sidewalks were in overall good condition; however, replacement of the sealant in the expansion joints as part of routine maintenance would extend their overall life.

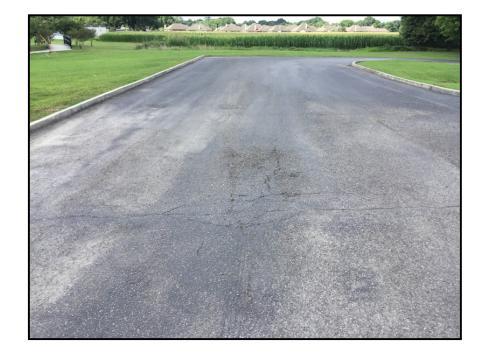
## Site Infrastructure

The asphalt pavements were in poor condition and need to be resurfaced.

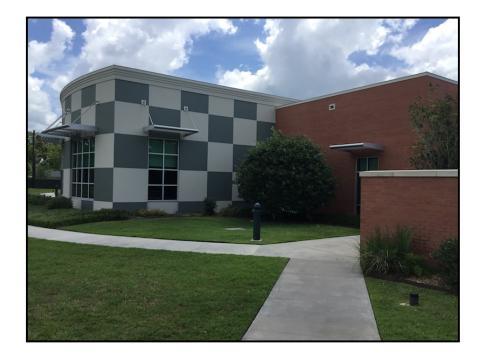
## **Exterior Enclosure**

The exterior wall system is a combination of brick veneer and painted stucco in good condition. The window system is comprised of double pane, insulated windows in metal frames observed to be in good condition.

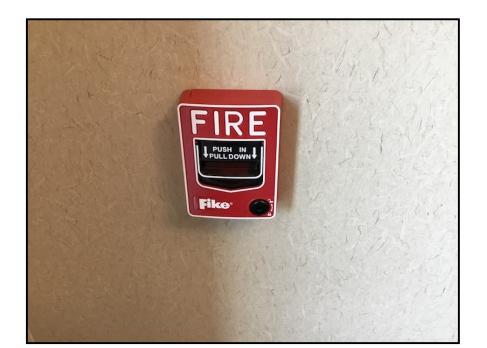
## **Fire Protection**

Exit lights and emergency lighting were present and observed to be in good condition. Battery backup has a limited life cycle and should be checked on a regular basis. Fire protection specialties were present. System components include pull stations, wet sprinklers and hard-wired smoke detectors. These systems are provided throughout the building and appear to be in good condition.

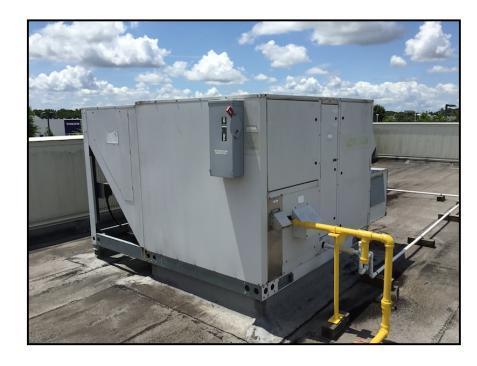
## **HVAC**

The Heating, Ventilation, and Cooling (HVAC) units are predominately split DX units, which are original and are in varying conditions. The Addison rooftop units were reported to have been in poor condition and not functioning correctly. The distribution system consists of ductwork and piping in good condition.

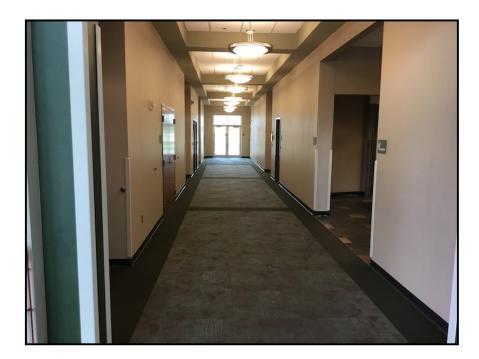
### Interiors

The interior wall finishes are a combination of painted surfaces, ceramic tile and wallpaper. The floor finishes are a combination of carpet tiles, resilient flooring and ceramic tile. Ceiling finishes are a combination of acoustical tiles and painted surfaces. All systems were original and in fair to good condition with a few deficiencies observed.

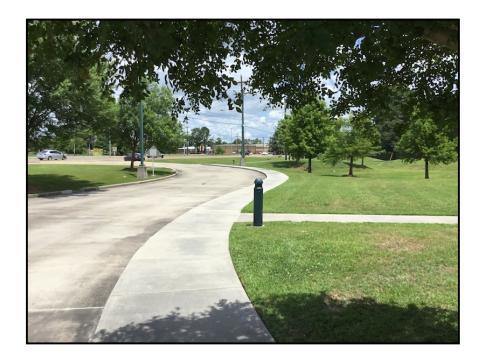
# Site Infrastructure

The concrete pavements were in overall good condition; however, replacement of the sealant in the expansion joints as part of routine maintenance would extend their overall life.
